National Register of Historic Places Registration Form

Historic name: Salisbury Village Blacksmith Shop

City or town: Salisbury State: Vermont County: Addison

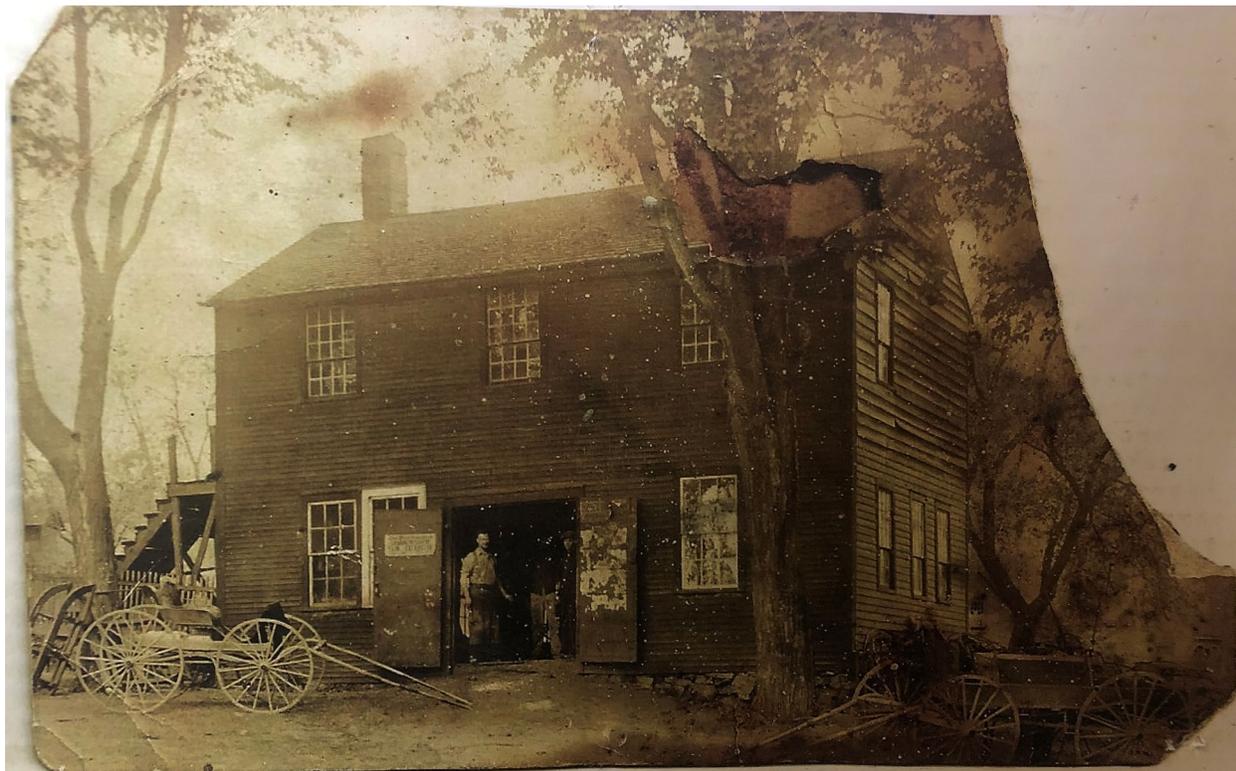
Figure 1: Circa 1915 photograph of Salisbury blacksmith shop's façade (Salisbury Historical Society).

The Main Block has undergone minor alterations, which are commensurate with the age of the building and reflect its long use as blacksmith shop. A c. 1915 photograph of the front and side of the Main Block (**Figure 1**) shows that the window immediately to the left of the entry doors had been installed by that time. The window and door openings shown in the photograph remain intact today, although the side-hinged entry doors have been replaced. On the far left of the image is an exterior staircase that led to the second story opening on the northwest side of the Main Block. This staircase is no longer extant, but the opening it served remains intact.

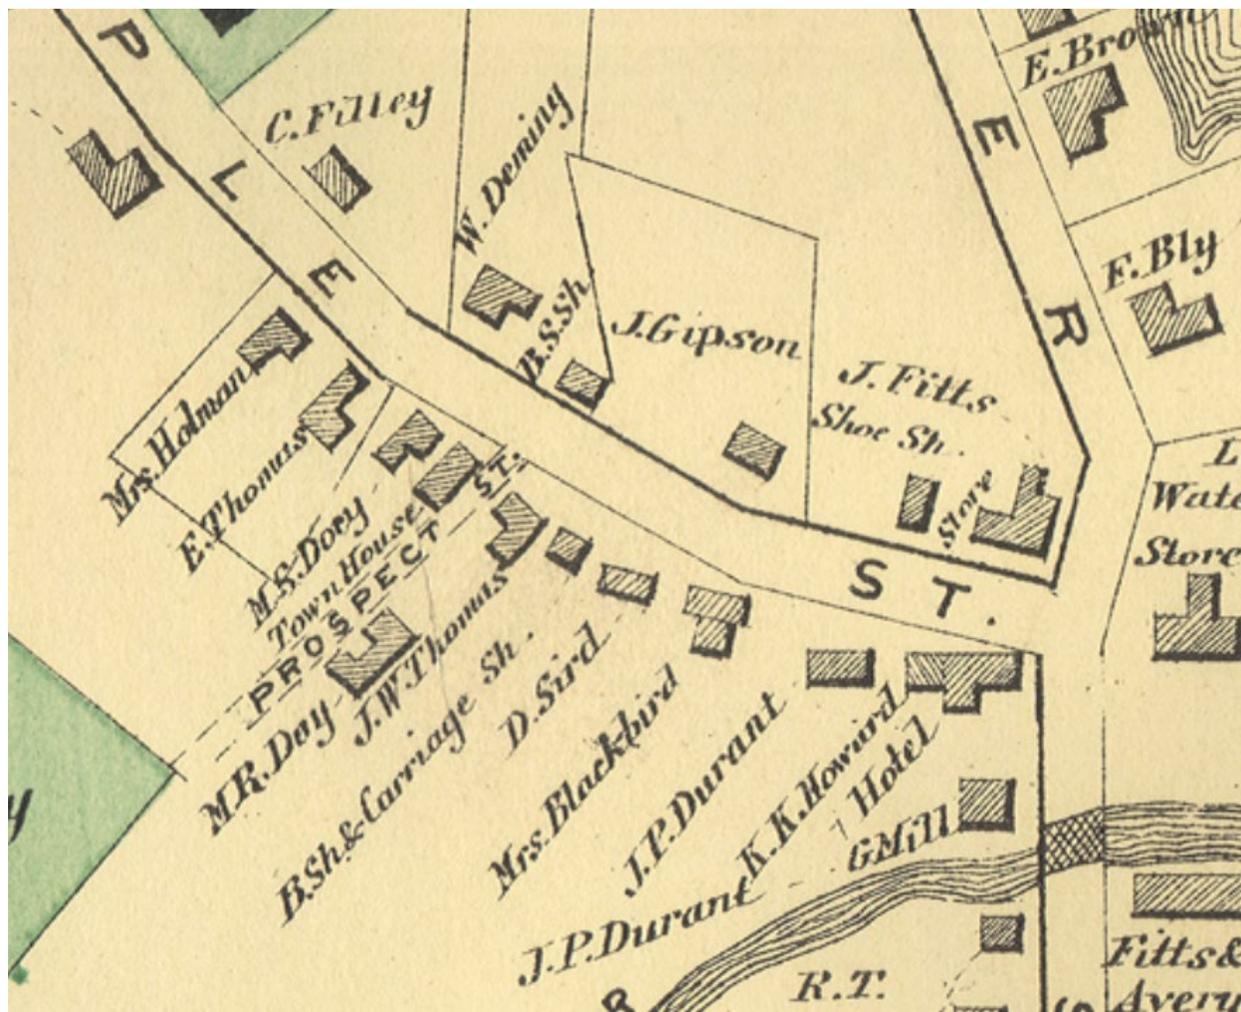
Figure 2: Detail of Salisbury Village from the 1871 Beers Atlas of Addison County. The home and blacksmith shop of W[illiam] Deming are in the upper left quadrant, and the footprint of the blacksmith shop ("B.S.Sh") does not include the rear ell.

The exact date of construction of the rear ell is unknown, but physical evidence suggests that it was constructed in the final quarter of the 19th century. It is not shown as part of the Salisbury Village Blacksmith Shop on the 1871 Beers Atlas, so its association with the shop post-dates publication of that map (Figure 2).

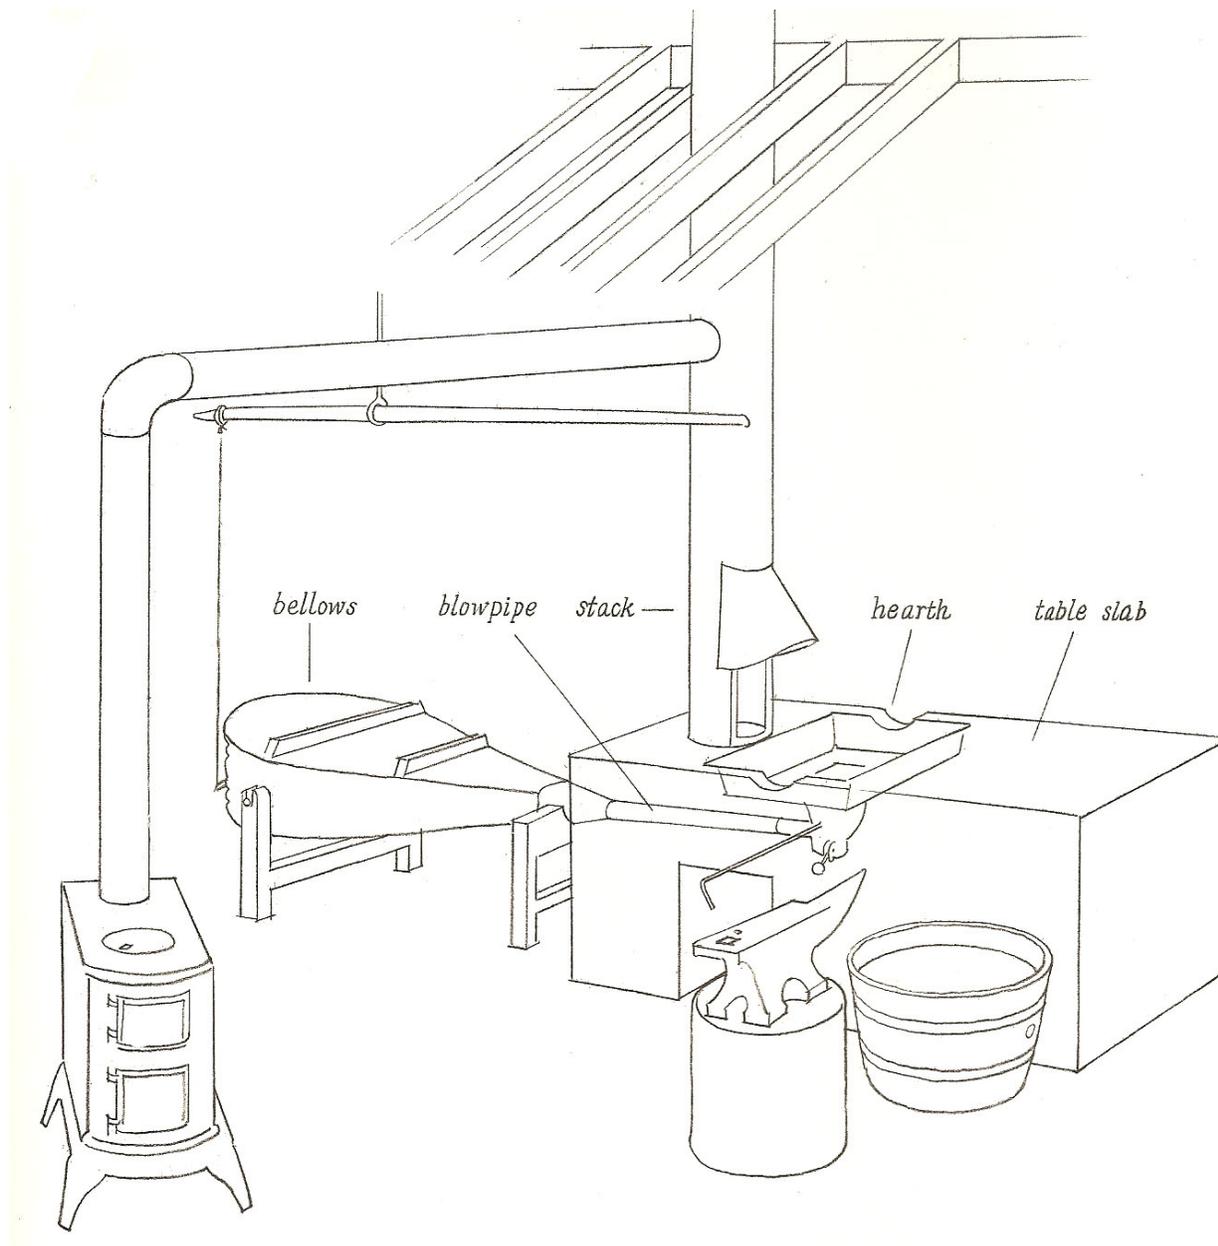
Figure 5: Diagram of a typical forge and related elements (Watson, page 103).

Beyond the building itself, the key components of a blacksmith shop are the forge (consisting of the hearth, chimney, bellows, and related construction) and the anvil (Figure 5). These elements are present in the Salisbury Village Blacksmith Shop and show how a 19th century blacksmith worked in the space.
